# Cracked Pipe

**By: Inspector Weeks 613.290.3697**

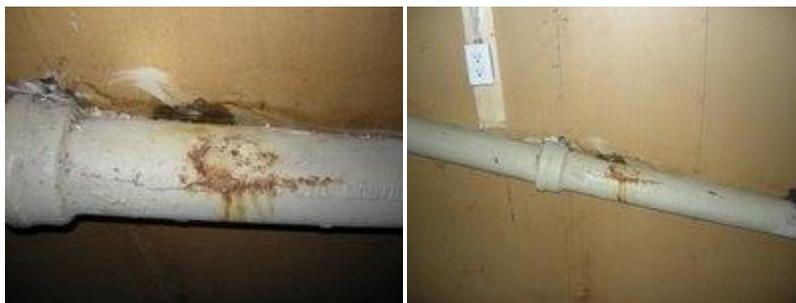
Yes, you are right to be concerned and thanks for the pictures. The pipes in the pictures are made of cast iron. Older cast iron pipes tend to be brittle and when put under stress will crack. The crack and the rust have obviously been there for a while and fortunately are on the top side of the pipe. For that reason the actual leakage of water from the pipe is only occasional as most of the time the flow of water is only along the lower half of the pipe. This pipe is more than likely a main sewage drain line. For health and safety reasons, my recommendation would be to replace the pipe right away. You have the option of replacing it with new cast iron pipe or cutting out the damaged area and replacing it with ABS plastic pipe with the correct fittings. With cast iron pipe you will hear less of the flow of the water, but considering it is in a basement ABS pipe would make a fine replacement at a lower cost. Be sure to take a good look at the rest of the exposed pipe for any other cracks or leaks and have them fixed at the same time. This kind of repair is best done by a professional.
